A JAPANESE STARTUP'S REVOLUTIONARY NEW EARTHQUAKE-RESISTANT COATING IS REINFORCING THE FUTURE OF SEISMIC RETROFITTING

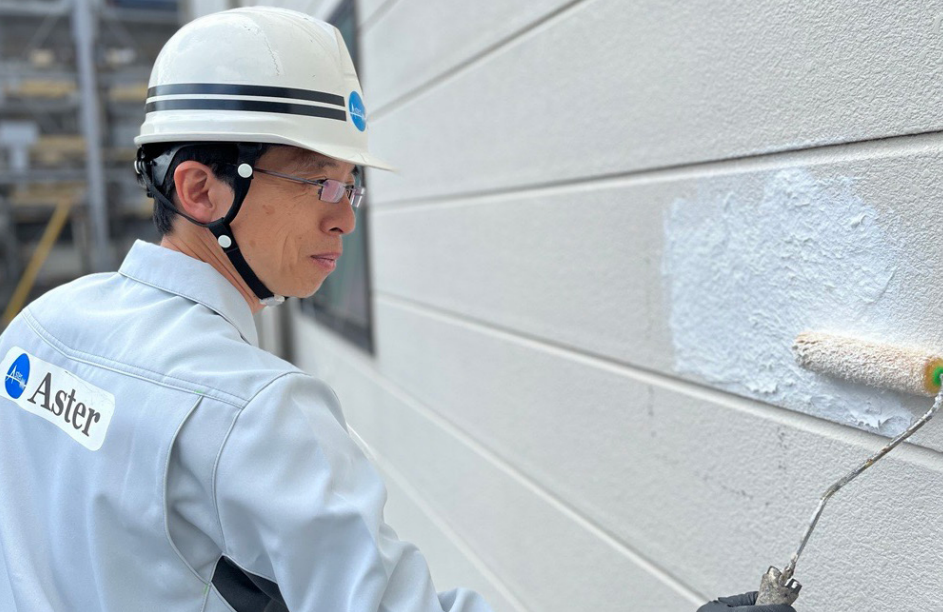
Left: SUZUKI Masaomi, CEO of Aster Co., Ltd., applies Aster Power Coating to a wall using a roller. ASTER
Below: Aster Power Coating contains both glass fiber and acrylic silicone resin.

The innovative product consists of short, hard glass fibers that can withstand being pulled from both ends, meaning that they won't stretch even during tremors capable of producing small cracks in walls. In addition, the material also contains soft acrylic silicone resin, the rubber-like flexibility of which prevents walls coated with it from collapsing, even during strong tremors.

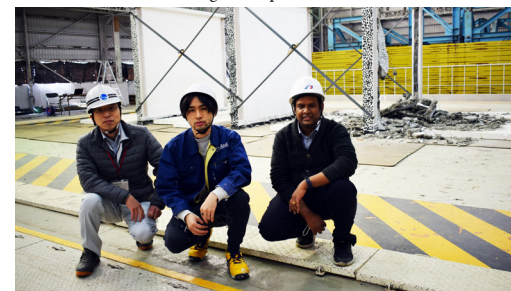
Scene from a vibration test conducted in Tsukuba City in 2022, in which walls made from blocks replicating those from the Philippines were subjected to earthquake-simulation tests. Walls without the company's coating (background right) were destroyed, while those with an application of dried coating (background left and center) had no obvious cracks and retained their original shape. ASTER

Before marketing their product there, however, they brought bricks used in the Philippines to Japan to replicate local masonry conditions, then conducted controlled vibration tests on walls to compare the effects of the new coating. After subjecting the walls to simulated earthquakes with a seismic intensity of 6 out of 7 on the Japanese scale—a level of shaking at which it becomes difficult or impossible to remain standing—seven times, they found that almost no cracks had appeared in walls with the new coating applied, whereas the uncoated walls collapsed after just one test.
